**SUBJECT: PUERTO RICO LANDFILL CAPACITY ASSESSMENT – HURRICANE
MARIA RESPONSE – YAUCO LANDFILL CAPACITY ASSESSMENT
STUDY AT YAUCO, PUERTO RICO**

Hurricane Maria Emergency Response
Yauco Landfill Capacity Assessment
Yauco, Puerto Rico

June 2018

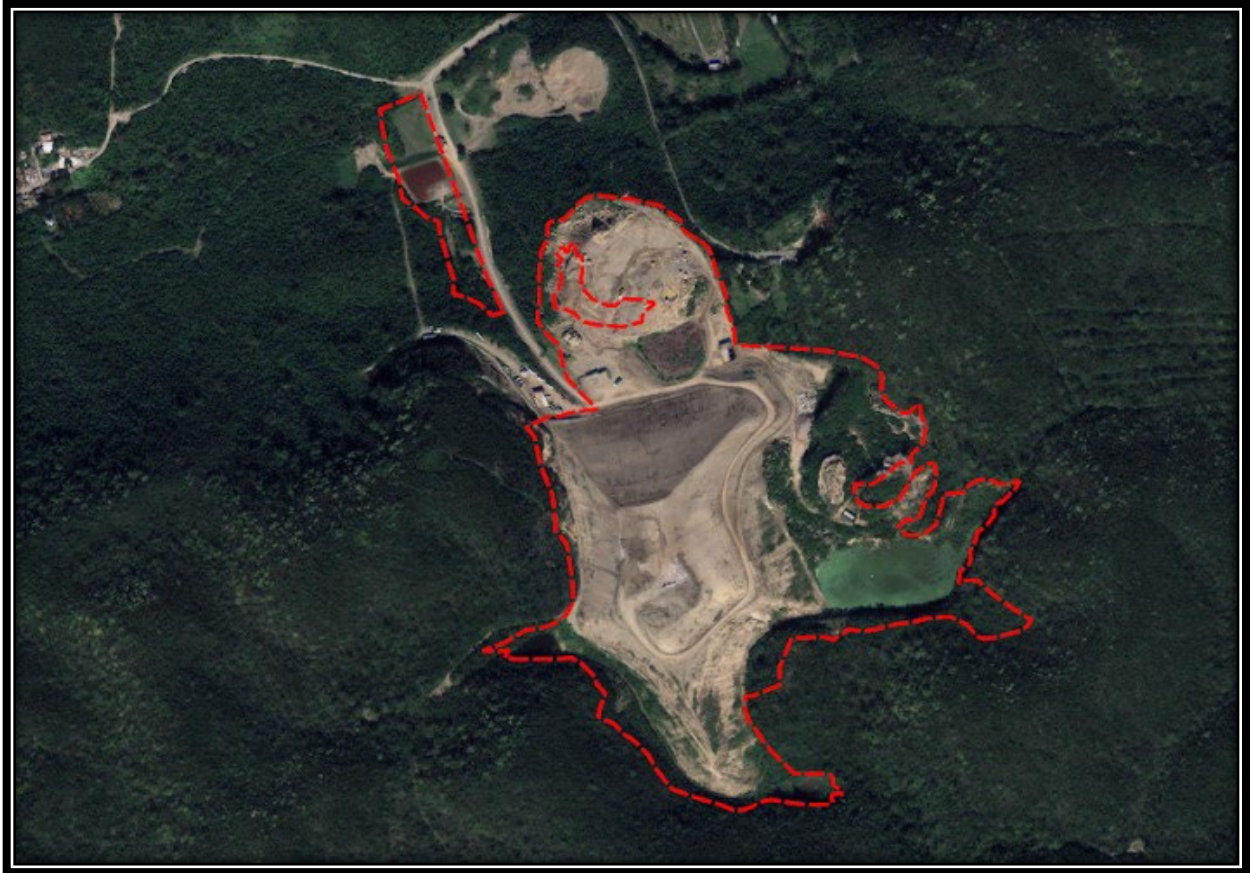
- Leachate seepages were observed on slopes of the north and west of the landfill.
- Administrative facilities were damaged by Hurricane María.

Figure I-1. Yauco Landfill Site View.

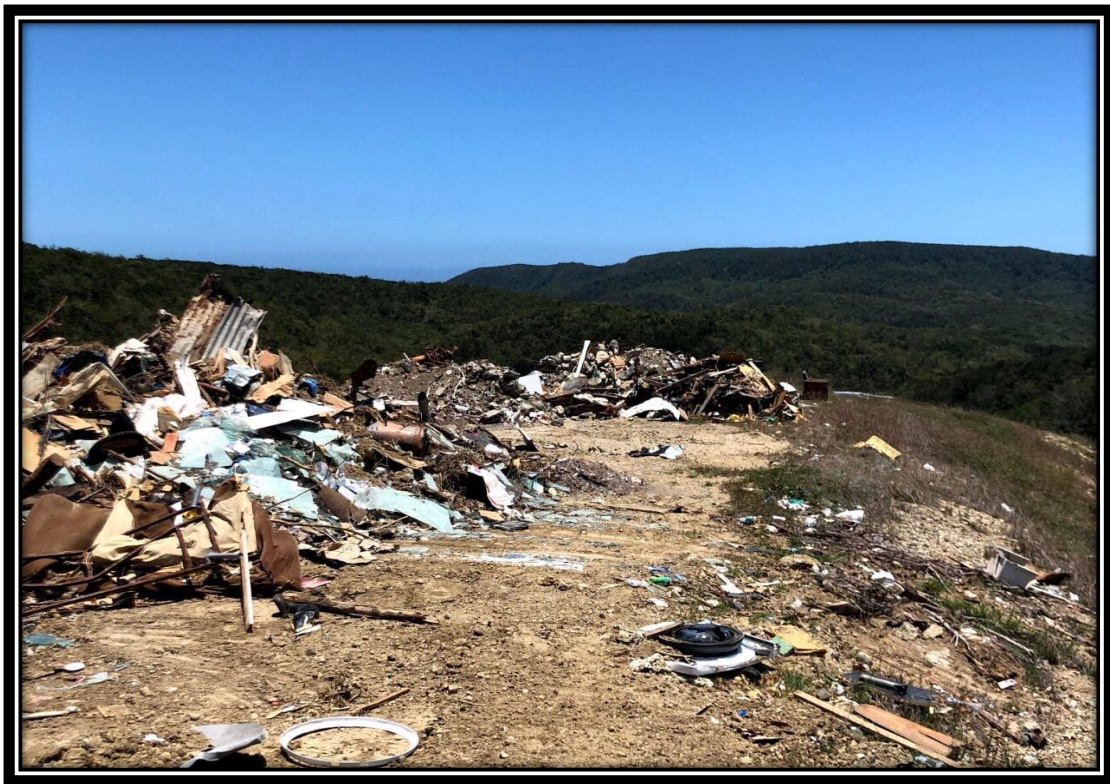
Figure I-2. Yauco Solid Waste and C&D left on the side of the roadway.

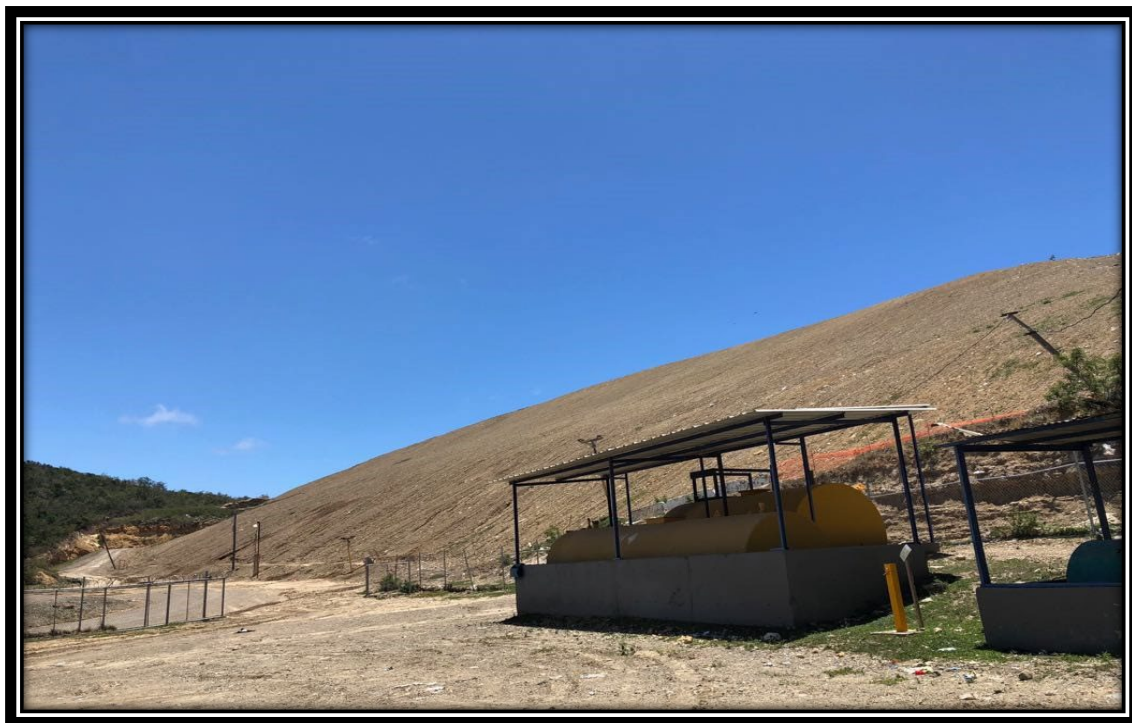
Maintenance and repairs of equipment were performed in a maintenance and storage area in the landfill. A 5,000-gallon (gal) fuel storage tank and a 3,000-gal used oil storage tank are located on the landfill property.

Figure I-3. Fuel storage tank and north slope.

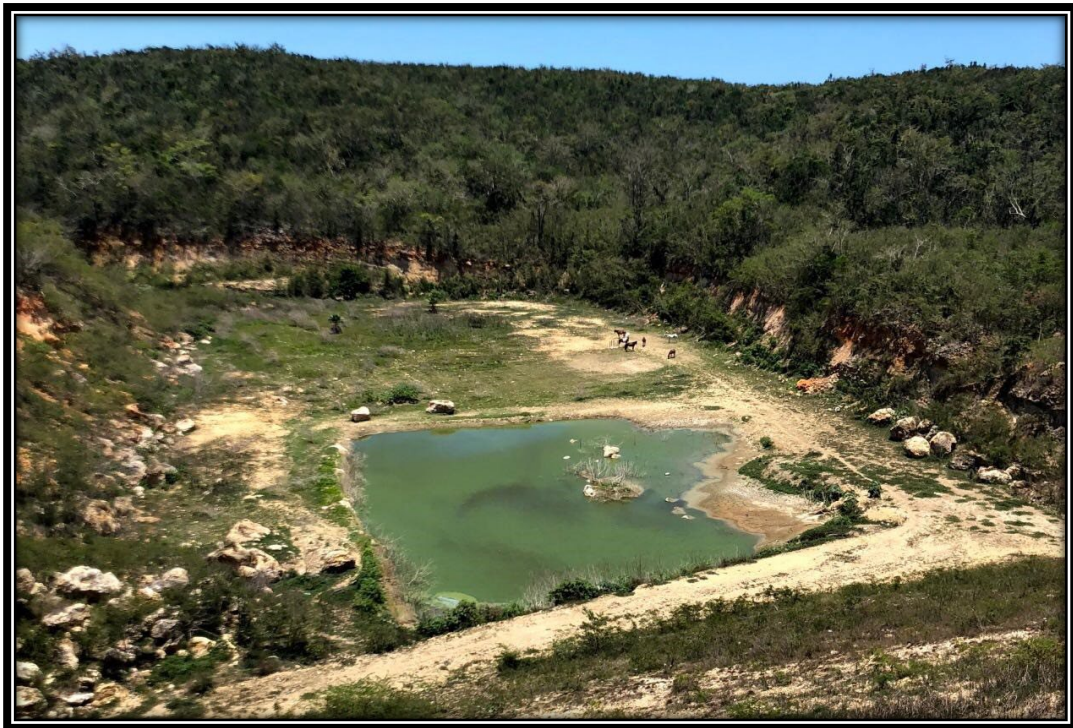
Site access is controlled with a perimeter fence and a no guard entrance gate. Some traffic control and disposal signs were observed during the site visit. The Yauco MSWLF has four retention ponds for stormwater. The landfill has no leachate collection system and does not have a gas collection control system (GCCS) in place. The Yauco MSWLF has five groundwater monitoring wells in place.

Figure I-4. East retention pond.

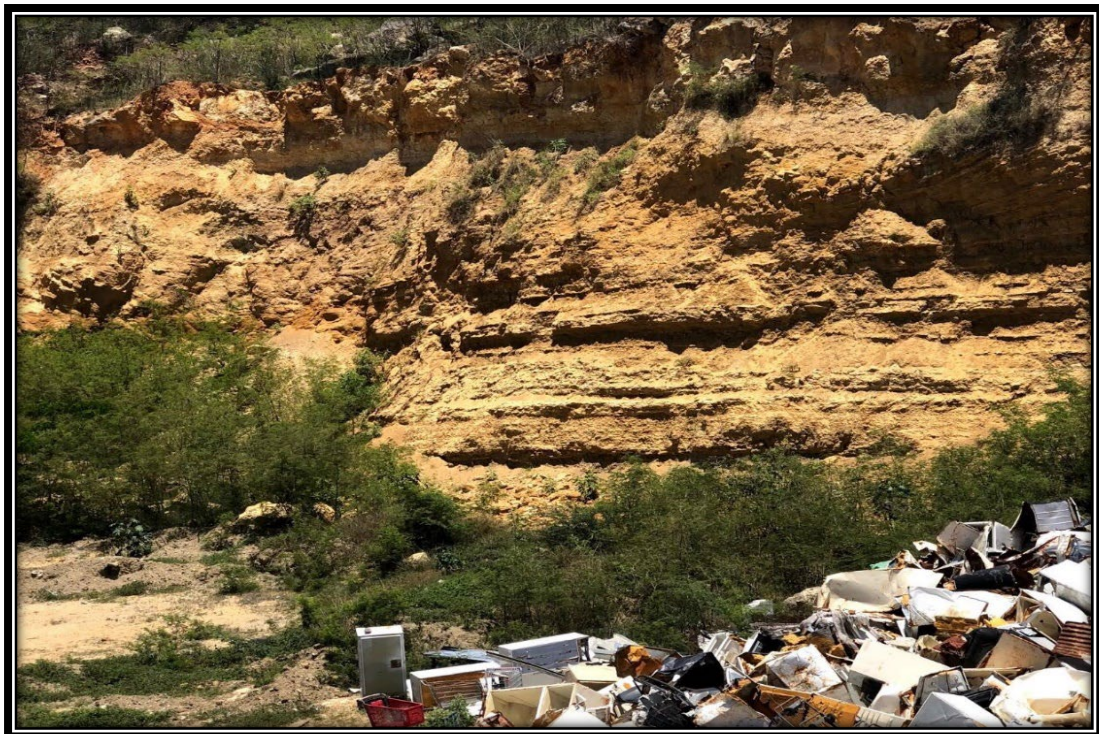
The Yauco MSWLF is at the center of the property and is approximately 30 ac. Extraction areas are located at the north and east area of the landfill.

Figure I-5. East extraction area and a pile of white goods.
